Manhole Inspection Summary

Manhole # S45K__023MH

Insp Date: **4/29/08 12:00 AM**

Location Address: **1744 aliceanna st**

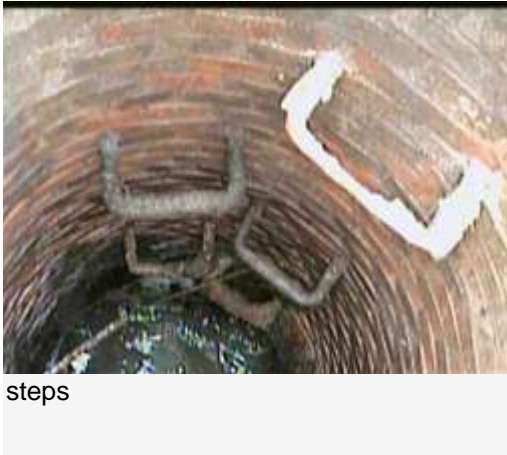
Defect 1

Count: **9** Missing: **4** ☒ **Corroded**

steps

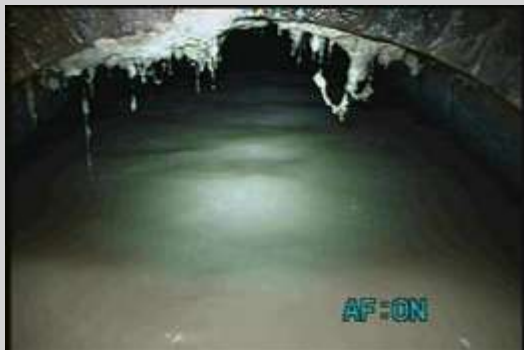
12 O'Clock Outflow

54 in. Circular Gravity Sewer
Pipe Out @ 12 O'Clock

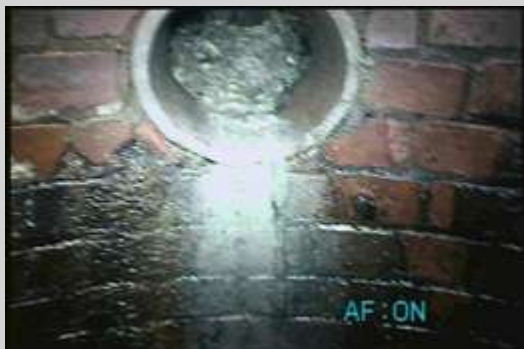
3 O'Clock Inflow

8 in. Circular Gravity Sewer
Pipe In @ 3 O'Clock

Deposits: ☐ None ☐ Mud ☐ Sludge ☒ **Debris** ☐ Grease

Silt Depth: 8 (in.) Deposits Extent: **Heavy**

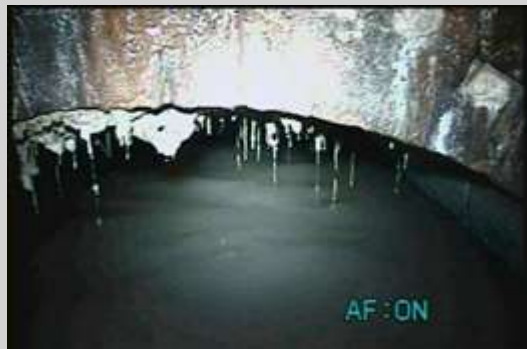
6 O'Clock Inflow

54 in. Circular Gravity Sewer
Pipe In @ 6 O'Clock
